## **Xemxija Bay - Proposed Beach Replenishment Project**

### **PROJECT DESCRIPTION STATEMENT**

**Version I: October 2011**

**Adi Associates Environmental Consultants Ltd, 2011. Xemxija Bay - Proposed Beach Replenishment Project. Project Description Statement. San Gwann, October 2011; vi + 31pp.**

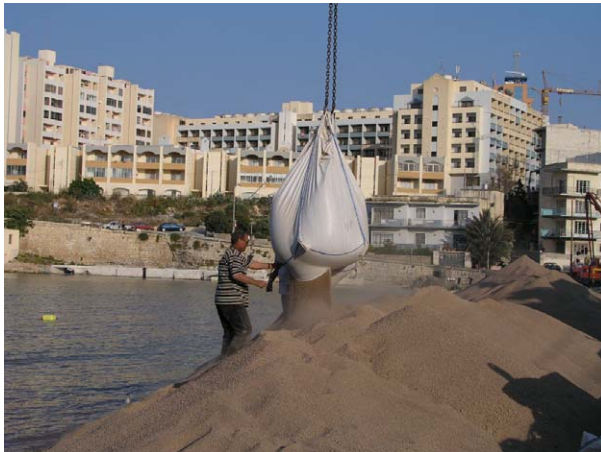
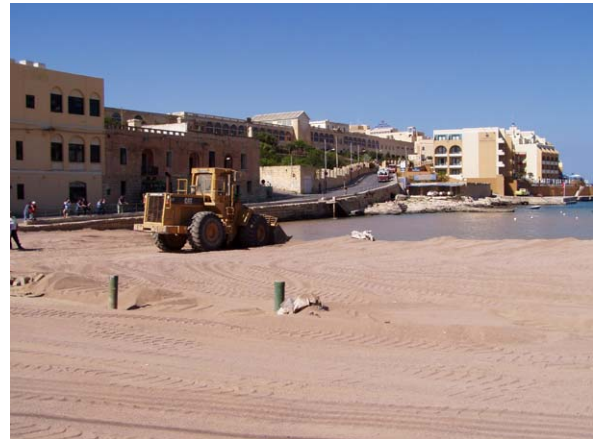
**Figure 2: Beach replenishment work at St George's Bay (2004)**

14. Following the initial appraisal undertaken in 2003, the MTA changed its focus to the replenishment of St George's Bay in St Julians, since the necessary environmental and planning studies had already been undertaken for this project and the then Planning Authority had approved its replenishment. St George's Bay was replenished in June 2004 (see **Figure 2**) and widened in 2005.

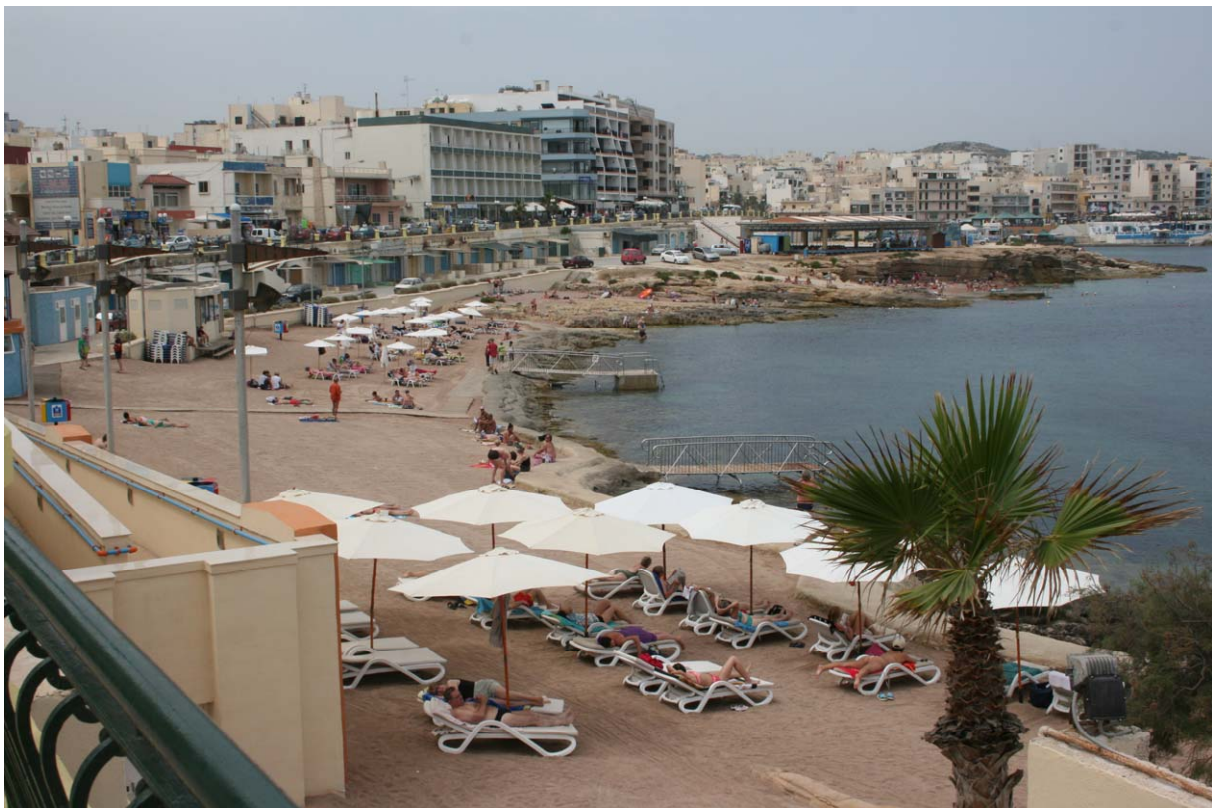
**Figure 3: The Bugibba Perched Beach**

15. Following the successful replenishment of St George's Bay and the positive experience with the management of the beach and its behaviour under different weather and storm conditions, the MTA turned its attention to the creation of a new beach in the Bugibba / Qawra area. In 2006, a new concept for beach development in the Maltese Islands was developed with the creation of the perched beach at Ix-Xtajta ta' Bugibba (**Figure 3**).

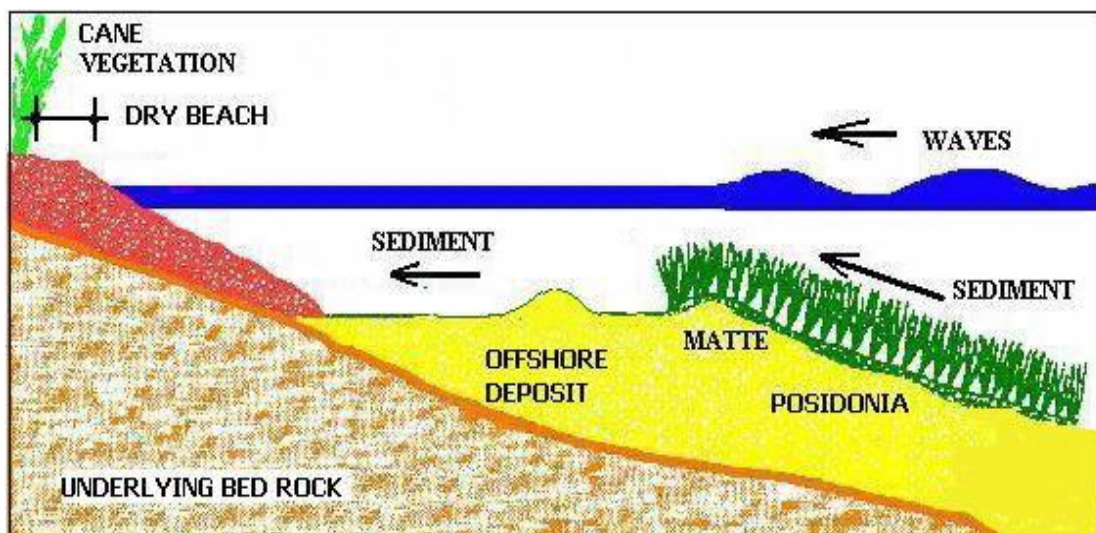
**Figure 4: Schematic representation of Maltese beach system**

20. The entire Xemxija Bay beach system originally extended from Pwales Valley all the way to the *Posidonia oceanica* meadows, as shown schematically in **Figure 4**.

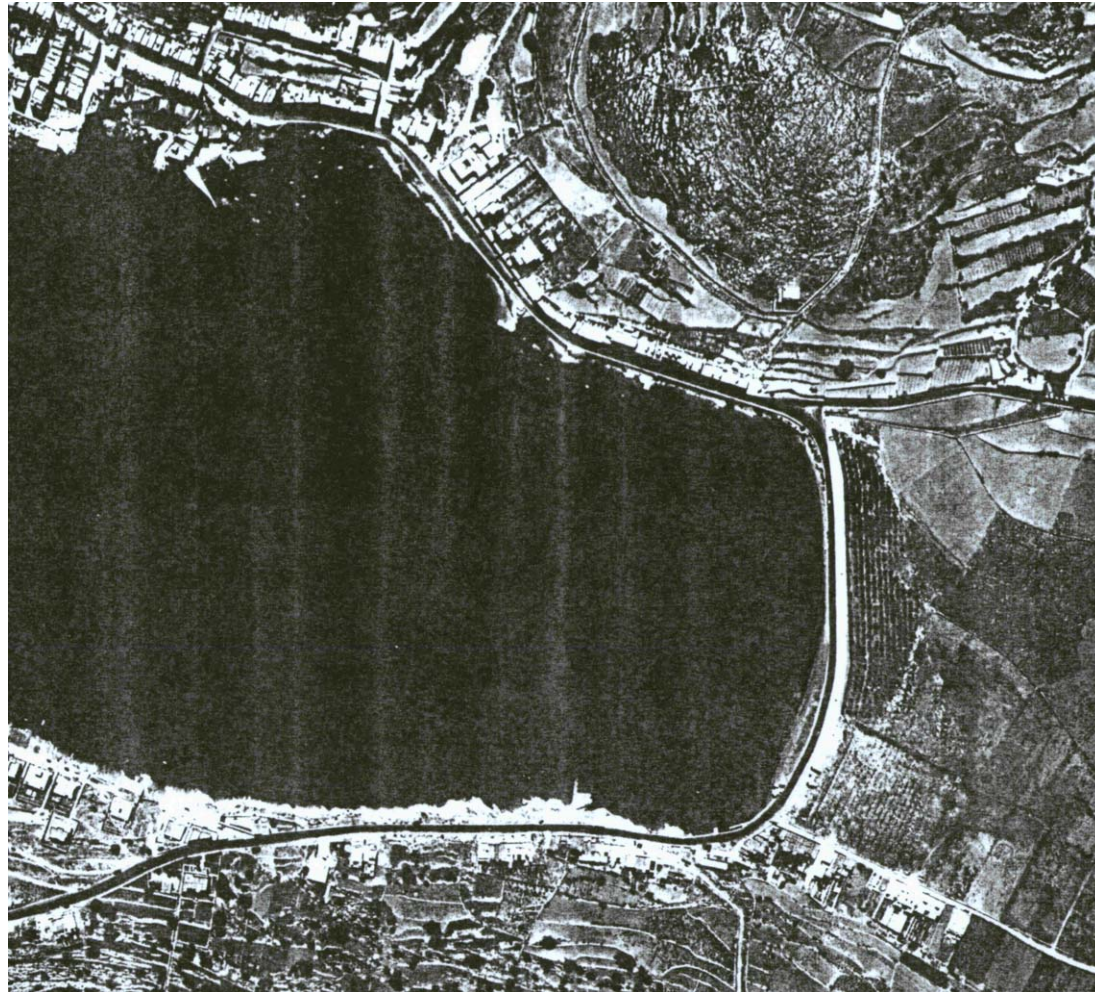
**Figure 5: Xemxija Bay 1957**

24. **Figure 5** shows the state of Xemxija beach in 1957, whereas **Figure 6** shows the bay in 2009. As can be seen, the beach in 1957 was already greatly eroded, though sand was still present across the width of the bay. The situation in 2009 is such that only a small pocket of sand in the northwest corner of the bay still exists.

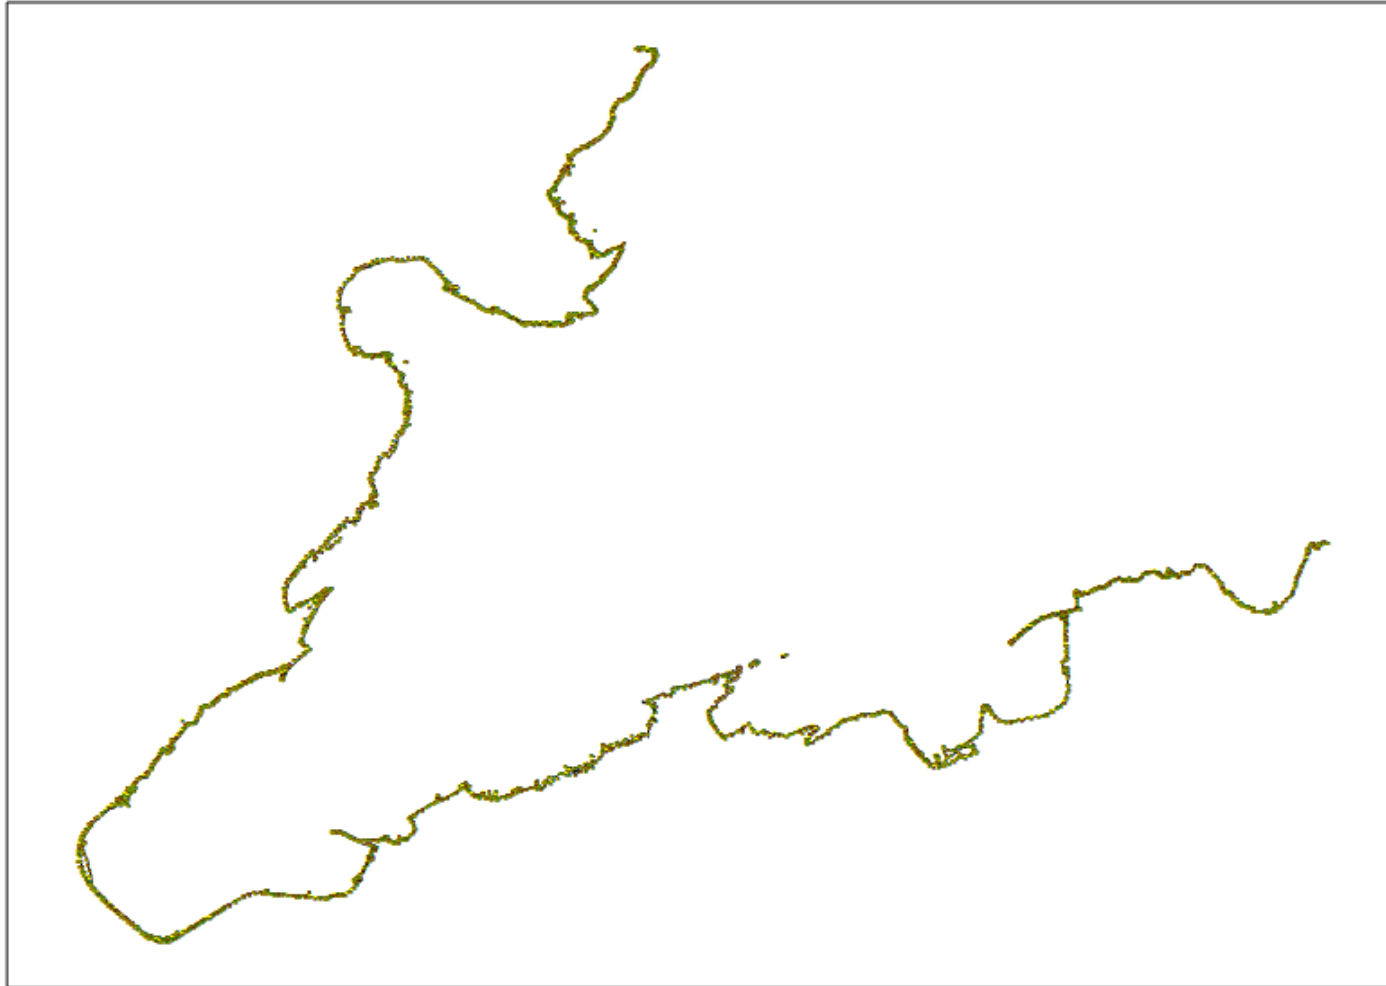
**Figure 7: Topography of Xemxija Bay**

- Geo-technical investigations on land and in the sea.
28. The topographic survey was undertaken by the Mapping Unit of MEPA using orthophotogrammatic techniques (**Figure 7**). The bathymetric survey (**Figure 8**), on the other hand, was carried out by the hydrographic office of the then Malta Maritime Authority (now Transport Malta).

30. These initial surveys provided crucial information for the decisions required in determining the feasibility of the initial ideas for the project. The topographic and bathymetric information confirmed the initial views that the location was ideal for beach replenishment work in that the ratio between the width and the depth of the bay coupled with the shallow depth of the embayment, especially in the inner part of the bay would ensure that the incoming waves would lose their energy well before they reach the beach. Indeed, the situation is similar to that obtaining in St George's Bay, St Julians, except that the bay is wider and longer and has a more extensive shallow area.

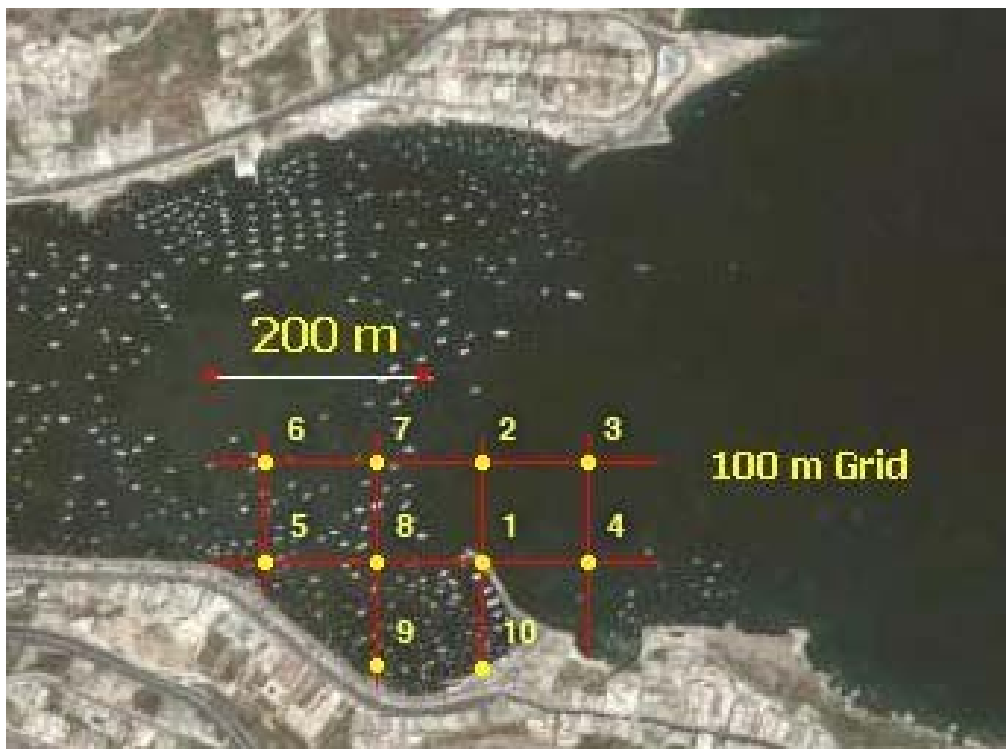
**Figure 9: Sampling points for sediment depth investigations**

31. The investigation of the depth of sand was concentrated in Il-Veccja area since it was postulated that this area may contain enough sand to allow for the replenishment of the beach without importation from elsewhere and the rest of the bay is known to contain extensive meadows of *Posidonia oceanica*.
32. The survey consisted of a grid of sampling points split into two areas (**Figure 9**):
  - Area 1 consisted of a 100m square grid on the eastern flank of the Ghar il-Veccja lighthouse; and
  - Area 2 consisted of a 100m square grid on the western flank of Ghar il-Veccja lighthouse and two stations along the shoreline to the south of the same grid.

33. A total of 10 stations were sampled, with two samples being collected from each station, whenever possible. Samples were collected from the surface and from 10cm depth (where available).
34. Six out of the ten stations sampled contained extensive growths of *Posidonia oceanica* meadows, most with well-developed mat structures. Eight of the 10 stations did not contain any sand.
35. Sand was sampled at:
  - 32m from station 3 at a depth of 7-9m (sediment thickness in excess of 1.5m),

- 3m from station 4 at a depth of 10m (sediment thickness in excess of 1.5m);
  - at station 6 at a depth of 3m (sediment thickness 0.7m); and
  - from a sand patch at 5m from the shoreline at a depth of 0.4m (sediment thickness 0.6m).
36. From these results it was ascertained that the sand present is not enough for the replenishment of Xemxija Bay beach. Thus, for the project to move forward, sand from other locations is required.

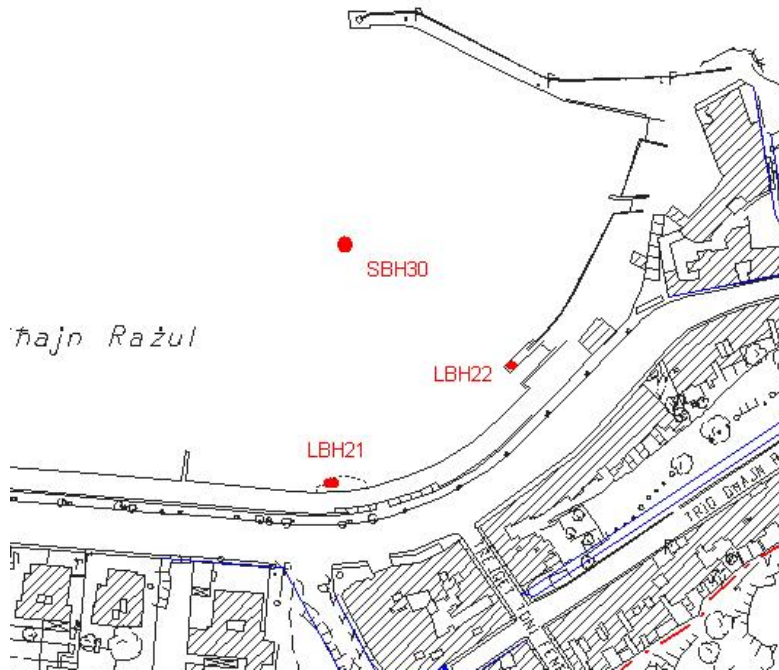
**Figure 10: Map showing location of boreholes drilled at Ghajn Razul (Il-  
Veccja)**

42. From these investigations, the following could be concluded:
- The rock sequence at Ghajn Razul is made up of Blue Clay and Upper Globigerina Limestone;
  - The only sand bed was found in the pocket beach at borehole location LBH21. It is about 1m thick but its lateral extent was not measured;
  - A buried valley (predominantly buried by Quaternary conglomerates breccias and red clay) is located at Is-Simar; and
  - A loose very soft clayey sand bed was encountered at borehole location LBH28 at 5.0 – 7.0m below ground level.

38. It was therefore decided to investigate this possibility by drilling boreholes in a number of locations complete with core recovery.
39. The geotechnical survey was commissioned by the Malta Maritime Authority as part of a Malta-wide geo-technical survey that was ongoing at the time (2006/7) through which the MMA was investigating maritime structures at various bays. The geo-technical investigations involved drilling of boreholes at Ghajn Razul (Il-Veccja) and Is-Simar. The works at Ghajn Razul included drilling of three holes (**Figure 10**), two from ground level and one at sea with open hole drilling through soil, soil sampling, SPTs and continuous rock core sample recovery for about 4m in rock. The works at Is-Simar included drilling of four holes (**Figure 11**) from ground level with open hole drilling through soil, with continuous soil sampling through the top 5m, and SPTs to bedrock followed by 4m of good quality rock core sample.

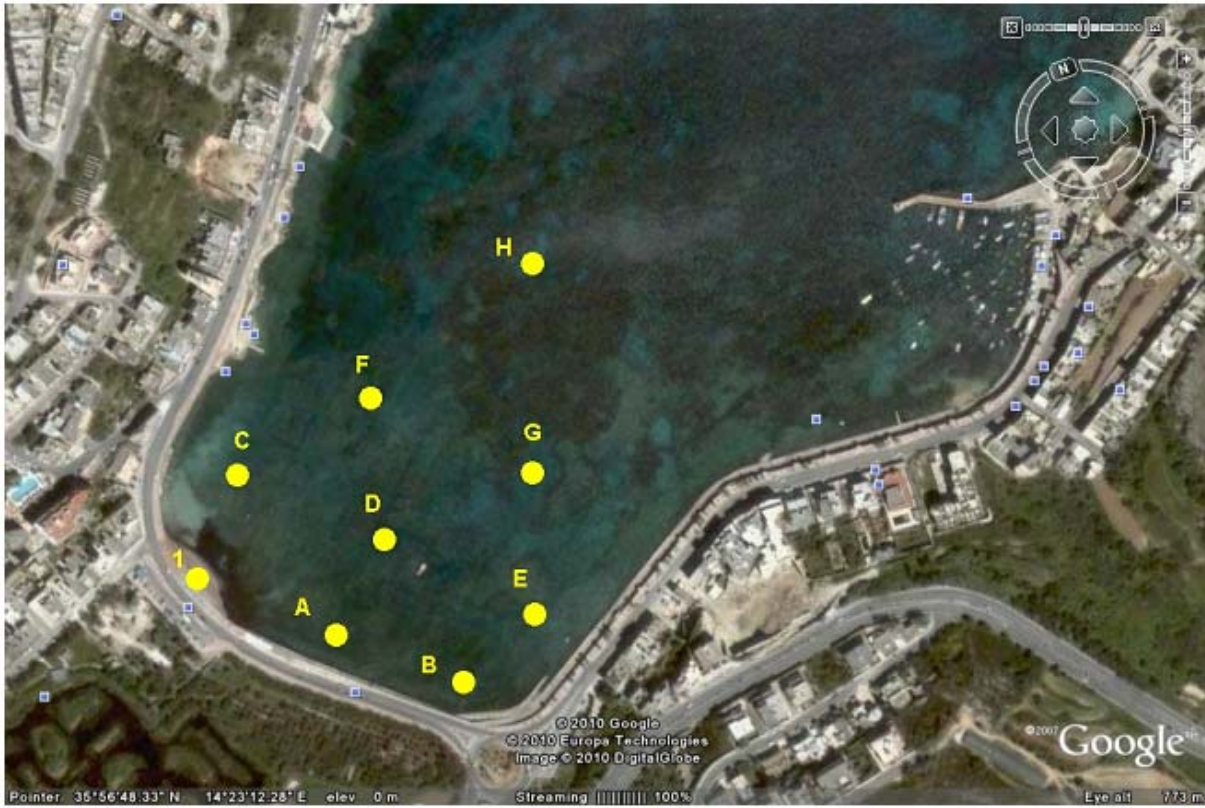
**Figure 12: Map showing location of sampling stations**

46. The environmental surveys on water and sediment quality were undertaken in April 2010 (Ecoserv, 2010).
47. The survey consisted of nine stations (one from the extant beach and eight offshore locations) (**Figure 12**).

49. The results from the analysis of these samples indicate the following:
- Some marine plant (mainly seagrass) debris were present at the surface at Stations B, C and E, but no abnormal physical features were noted during the surveys;
  - Nitrates, phosphates & chlorophyll a levels were all below pollution threshold levels for local coastal waters;
  - Enterococci & E. coli counts were both well below guideline and mandatory values;
  - Levels of metals and organic compounds in the water were below the values of national and EU quality objectives;
  - Levels of Aluminium were found to be elevated in all stations;
  - Levels of pesticides, mercury and organotins in the sediments were all found to be below the reporting limits;
  - As regards granulometry, results indicate that the sediment is composed of gravelly muddy sands with a mean grain size varying from 0.08 to 0.65mm; and

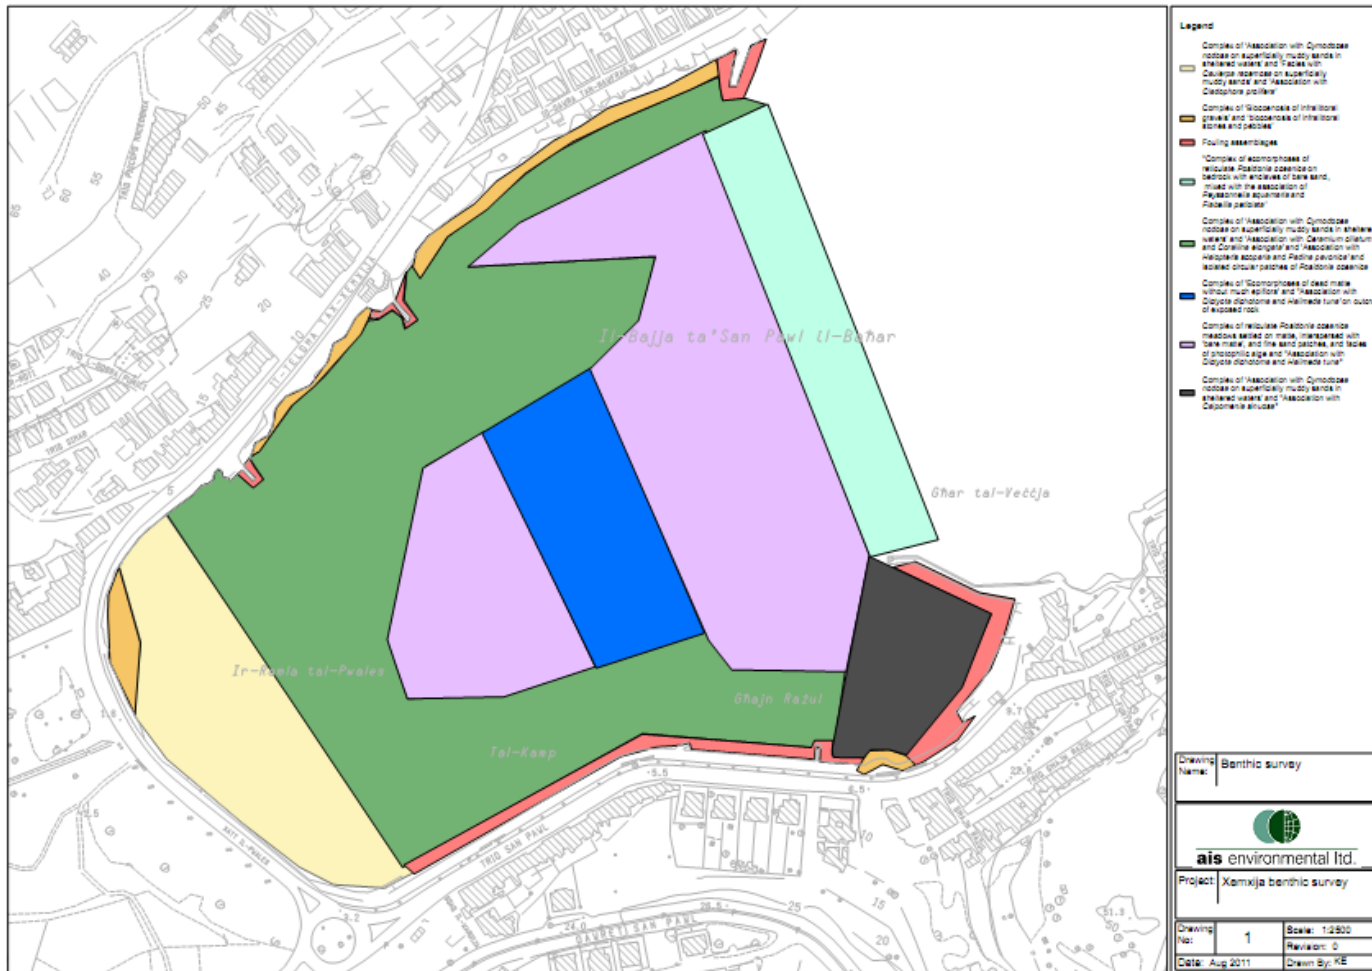
**Figure 13: Map of the benthic habitats at Xemxija Bay**

51. In view of this positive result it was next decided to assess the feasibility of the proposed replenishment through a mathematical hydrodynamic model. Information required for the modelling included the topography and bathymetry data already collected, as well as details on the habitats present on the seabed. For this reason, a benthic survey of Xemxija Bay was commissioned in 2011. The survey, which was undertaken by AIS Environmental Ltd, mapped the benthic habitats within the inner part of Xemxija Bay (up to Il-Veccja breakwater) (**Figure 13**).

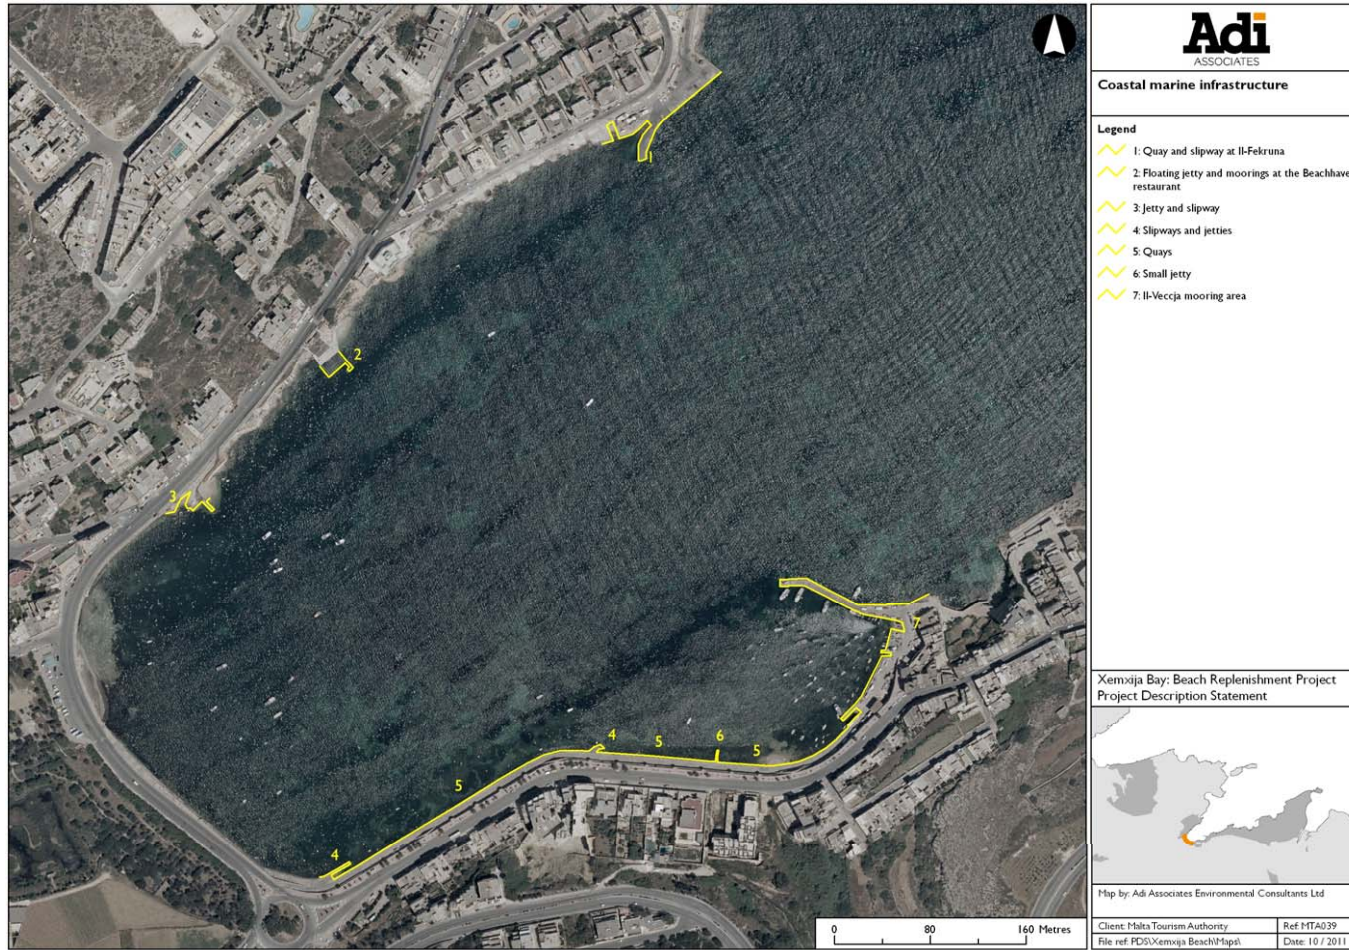
**Figure 14: Coastal maritime infrastructure in Xemxija Bay**

62. Access to the sea is currently possible from the pocket of sand in the north-western corner and via the ramp leading to the slip way in the southwest corner.
63. Access is also available from the small jetty and slip way on the north shore and from the Fekruna area in the north and the Veccja area to the south.
64. A number of staircases provide access from Triq San Pawl to the quayside on the southern shore and from Xatt il-Pwales to the concrete pathway at sea level beneath the road's retaining wall.
